## Reduction of Bank Erosion

### Action C1

### LIFE09 NAT/IE/000220 BLACKWATER SAMOK

June 2015

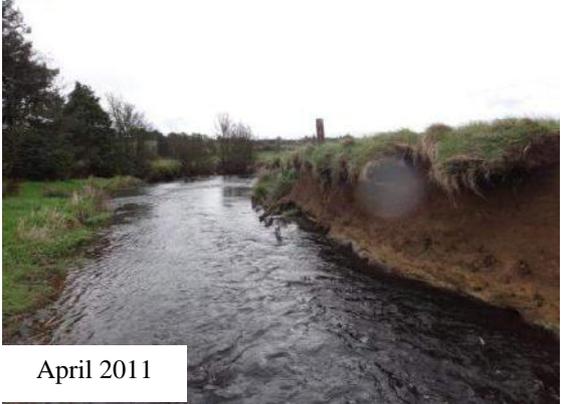
<p data-bbox="245 667 368 703">April 2011</p>

Before	After
Repair of IFI restoration works (Allow River)

Retrofitting degraded Log Christmas tree revetment: The technique has been successfully trialled in rivers throughout the West of Ireland (Shannon International River Basin District Project, 2008) and was trialled in Duhallow in tributaries of the upper Blackwater, including the Rivers Allow and Owentaraglin. Some of the work carried out on the River Allow, conducted in 1999 funded under the Tourism Angling Measure (EU Structural Funds) had come under pressure due to changing hydrological characteristics upstream. In addition, in some locations the fence line along the river banks was too close to the river edge allowing bovines to graze re-established riparian vegetation, thereby undermining the protection work. Walk over surveys in 2010 identified a number of areas where these structures were under threat of failure and a restoration programme was initiated. This involved the placement of stone beneath logs which were being exposed due to river bed down cutting (an issue identified by the project (Blackwater SAMOK, 2011)) and placement of new Christmas trees on top of these logs. These Christmas trees were jammed in between the logs and the eroding banks to provide maximum protection during high water events. Locally sourced willow stakes were planted on the bank side of the logs and up along the banks where possible.

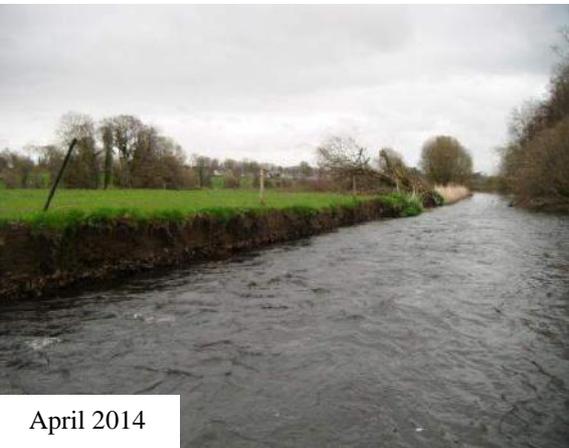
<p data-bbox="240 1205 363 1240">April 2014</p>

<p data-bbox="842 667 965 703">June 2015</p>
Riverbank restoration (Dalua River)

This technique involved the sloping back of the severely eroding river bank. In the Allow Catchment, eroding banks range from 0.5m up to in excess of 2m in height and therefore provide a challenge from an engineering perspective. The technique involves the minimal use of rock in combination with river bank reprofiling, utilisation of the original grass turf where available, planting of native trees especially willow, utilisation of used Christmas trees and fencing, and the management of grazing animals. Environmental considerations include the prevention of localised silt disturbance and instream disturbance.

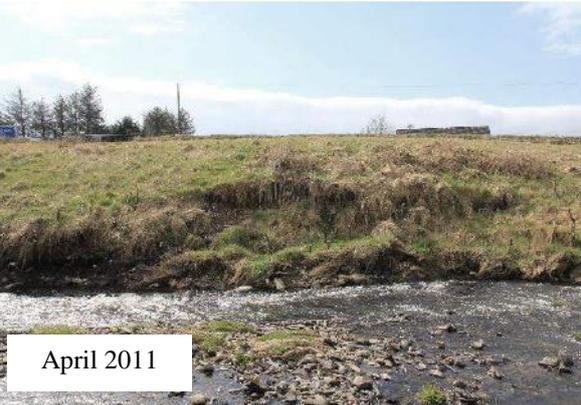
<p data-bbox="245 1671 368 1706">April 2011</p>

<p data-bbox="842 1189 965 1225">June 2015</p>
Willow Spiling (Allow River)

Spiling is a traditional technique used in temperate regions of the world for the prevention of erosion to river and stream banks. Willow, because of its suppleness and ease to work with, together with its ability to root easily and grow quickly is often used. In addition, it grows naturally in wet areas so is able to withstand a certain amount of inundation and ground saturation due to flooding. The technique involves the cutting of live willow rods, which are woven between live willow uprights secured in the ground. The area can then be backfilled with soil for the willow to root into.

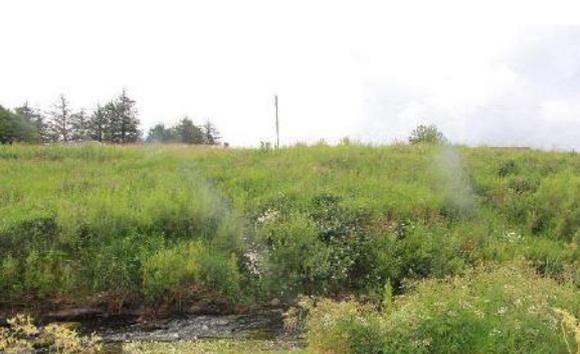
<p data-bbox="820 1671 1380 1733">June 2015 (Willow and Alder were planted behind the spiling works)</p>

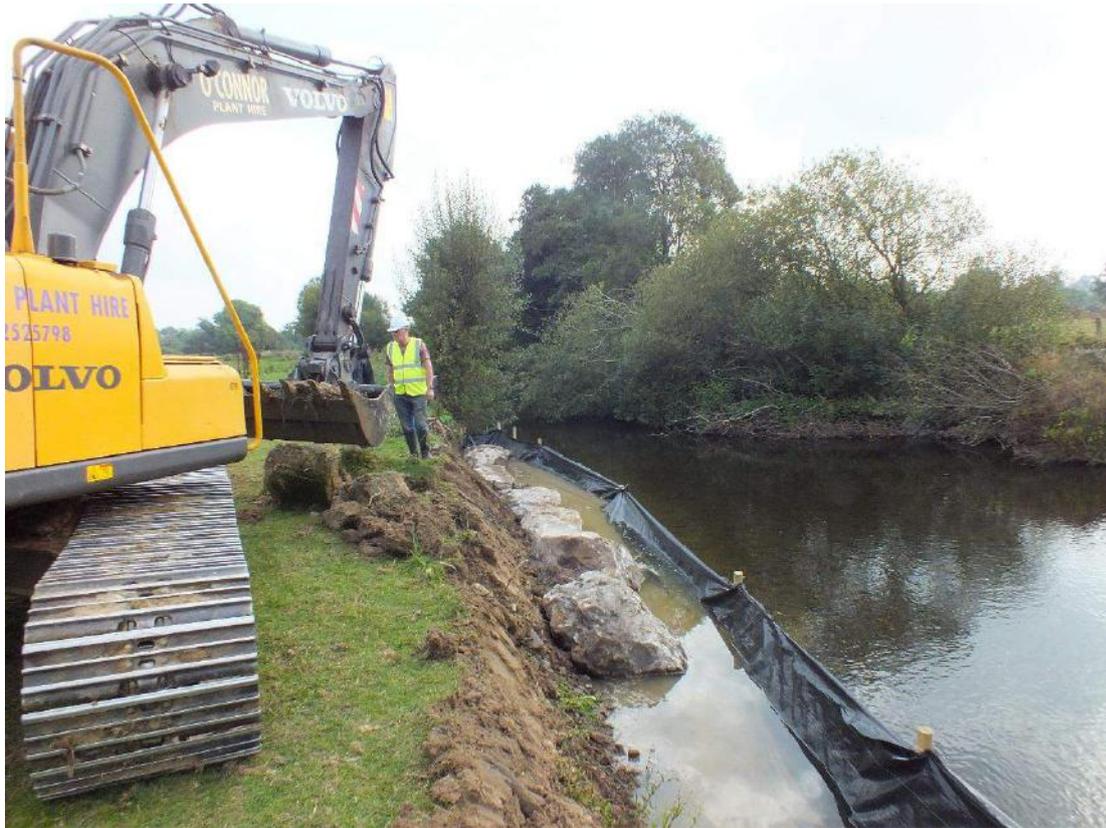
Figure 6 Rock placed at toe of bank. Note the colour of the water within the silt curtain compared to water outside.

- Rock was placed at the base of the eroding bank parallel with the river flow and inside the water edge.
- The grass sod was peeled back for approximately 1.5m in the field (top of eroding bank) and banked.

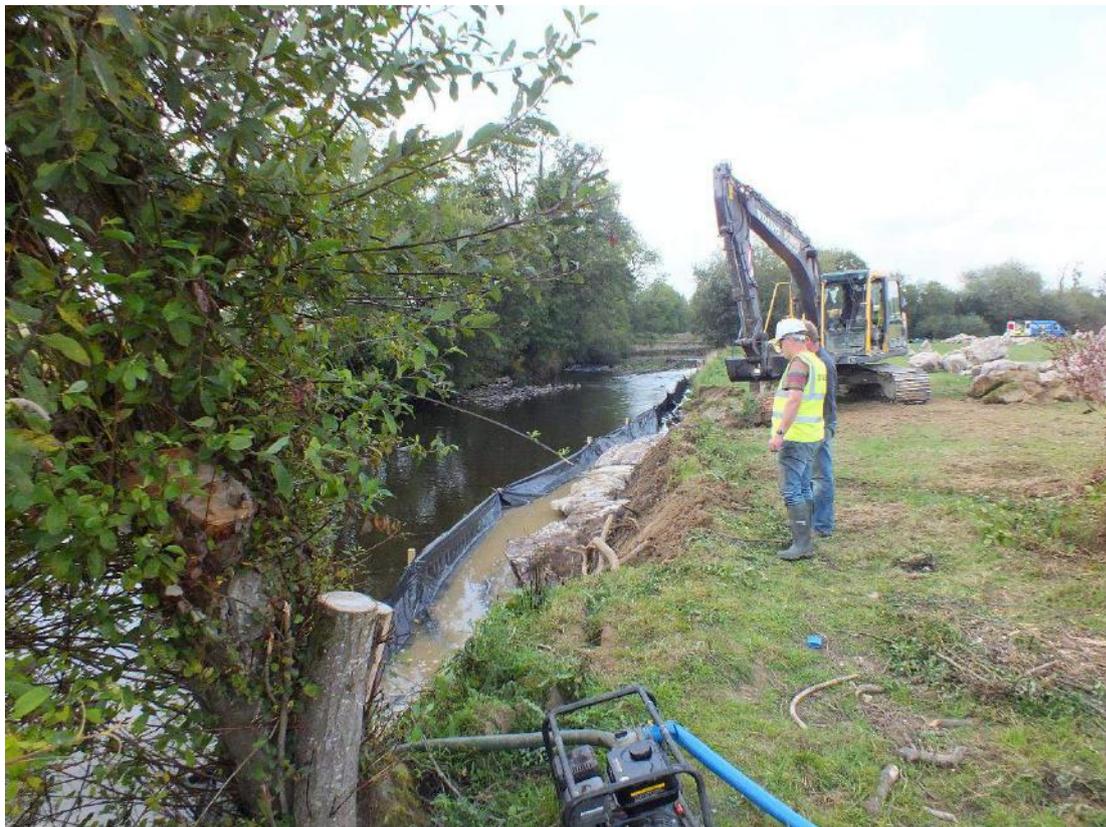
Figure 7 Pump (foreground) pumping silted water from within the silt curtain. The water was pumped out into the field, where it drained into the soil.

The work was carried out during low water flows to reduce the risk of silt loss. A silt curtain was deployed parallel to the river bank and water flow to contain any silt in suspension. This was pumped back into containment areas in the adjacent field and allowed to filter back to the main channel ensuring that any fine material was removed. Water samples were taken 25m

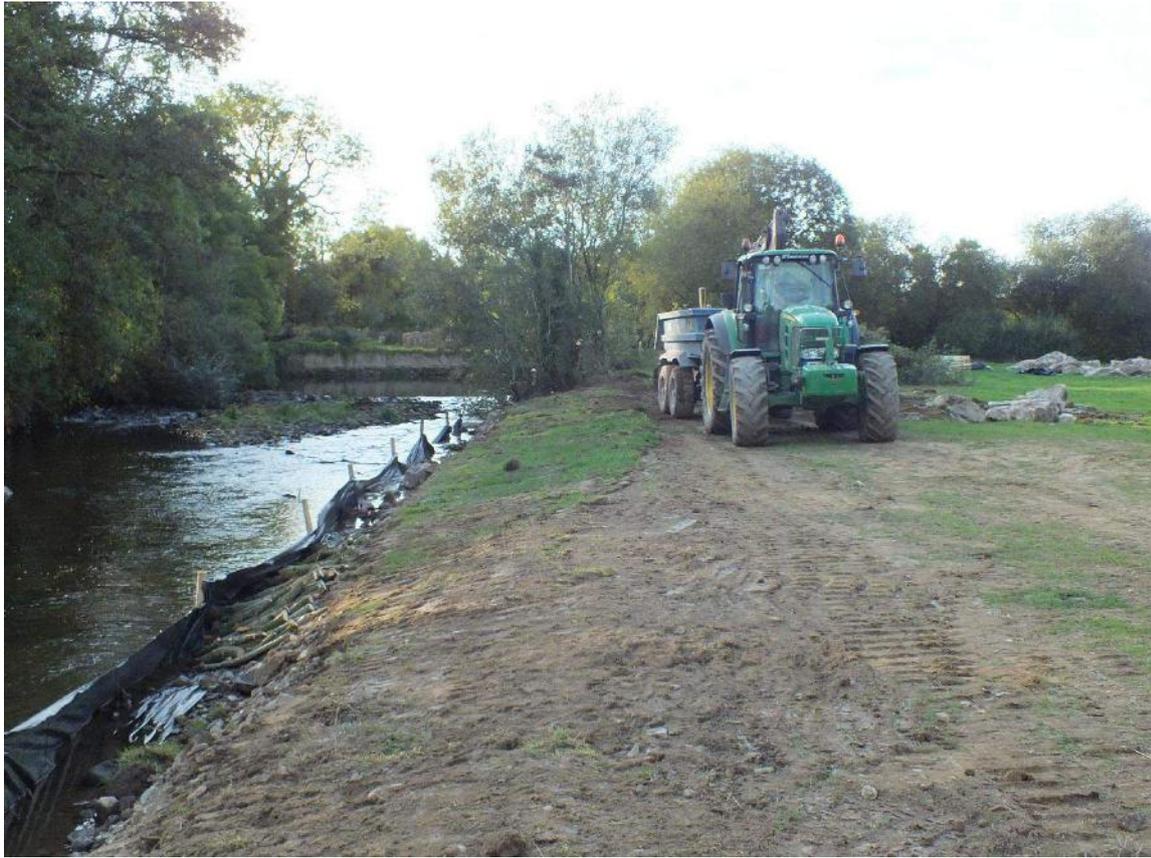
Figure 8 Riverbank has been reprofiled and the origin top sod replaced.

- The banked sod (peeled grass strips) were then placed back onto the new sloped bank and watered to encourage immediate growth.
- Large willow stakes (10cm to 30cm in diameter) were also placed at 1m intervals to accelerate the growth of the riparian zone.

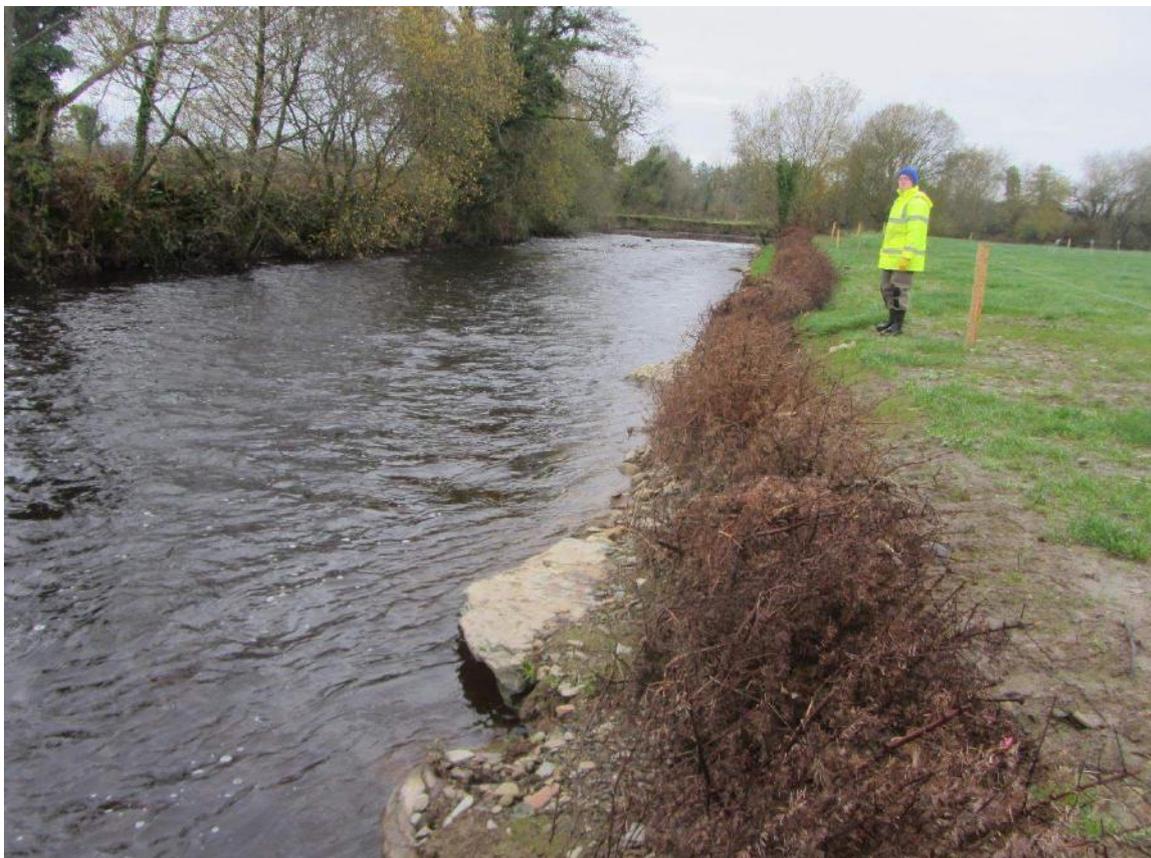
Figure 9 Christmas trees secured to the newly reprofiled bank ensure added protection while willow stakes and fascines root and grow.

- Christmas trees were then secured on the more vulnerable portions of the bank (lower portion) by screwing them to live willow stakes to provide initial buffering and protection from flooding (should flooding occur soon after the completion of works). In some instances, where the willow was judged to be too soft to hold in screws, fencing posts (cut in half) were used instead.
