**Rebalancing of riparian vegetation to address areas affected by  
excessive shading –  
Monitoring Report**

**Action C5**

**LIFE09 NAT/IE/000220 BLACKWATER SAMOK**

June 2015

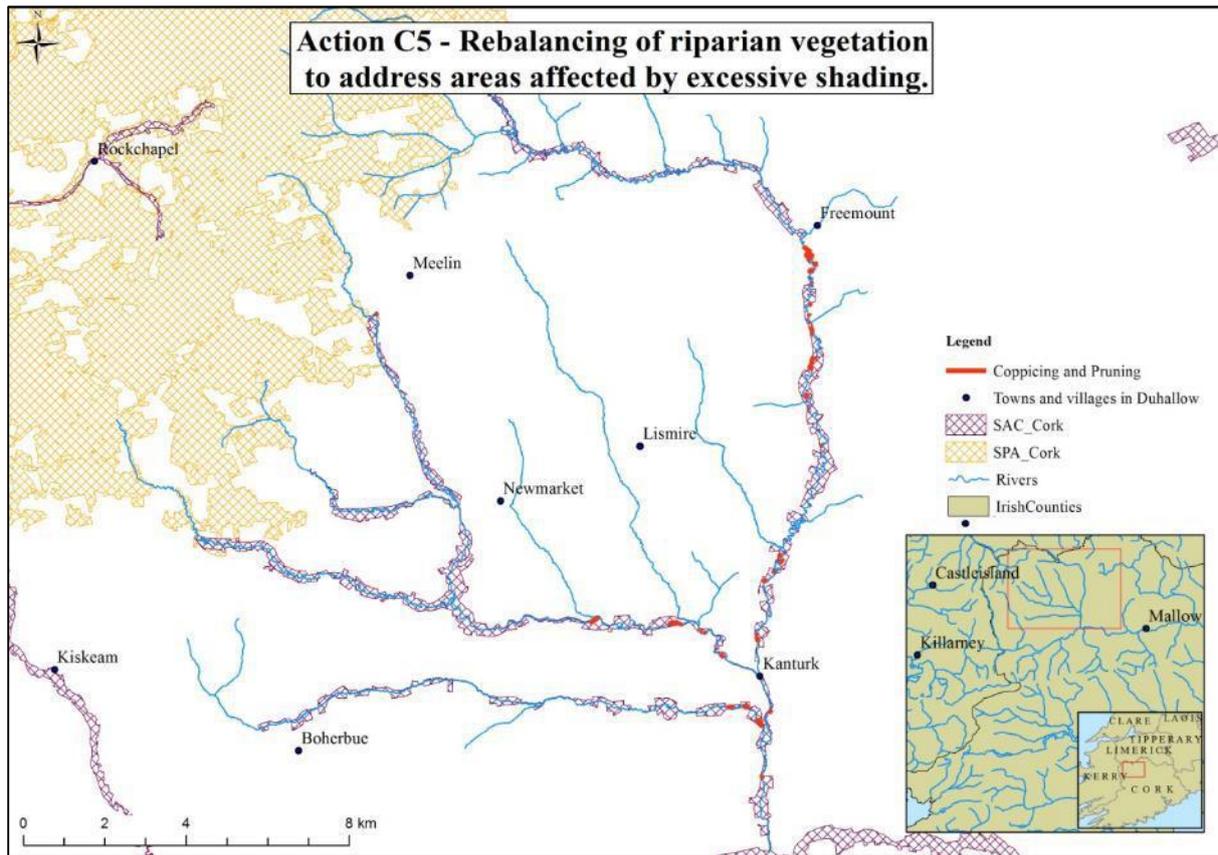
Figure 2 Extent of coppicing and pruning conducted along the Allow, Dalua and Brogeen Rivers.

In total, riparian tree pruning was carried out along 3.11km of a 6.46km length of river bank (Figure 2). The before and after photos (spanning a 3-year period from 2011 to 2014) show the extent of trees and branches removed from the banks of the Allow, Brogeen and Dalua Rivers (Table 1). The selective removal of trees and shrubs can result in a dappled effect that allows light to penetrate the water. This encourages photosynthesis of macrophytes while keeping temperatures low (Forest Service, 2000).

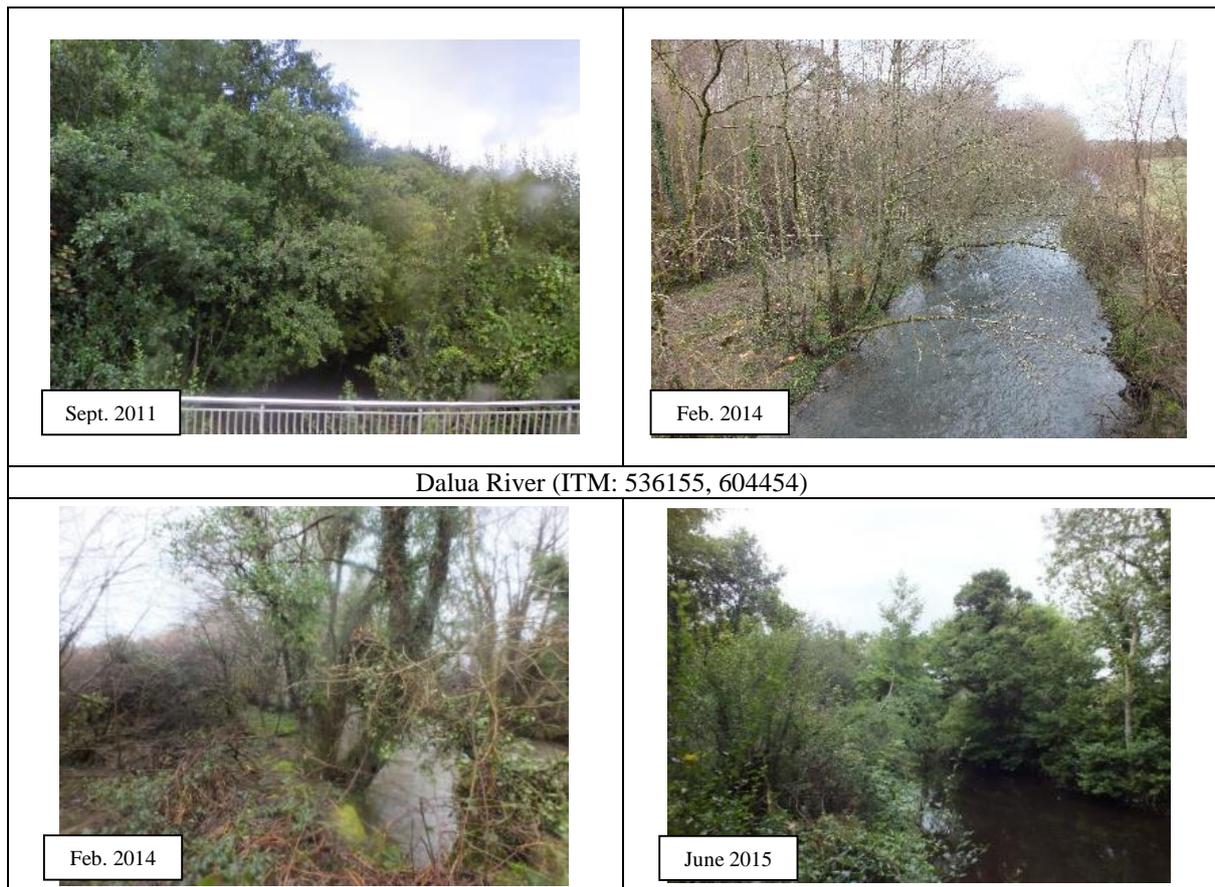
Table 1 Sites along the Allow, Dalua and Brogeen Rivers where coppicing and limbing were conducted (before and after).

Before	After
Allow (ITM: 539317, 610073)	
<p>May 2011</p>	<p>Feb. 2014</p>
Brogeen (adjacent to Kanturk Castle) (ITM: 538188, 601804)

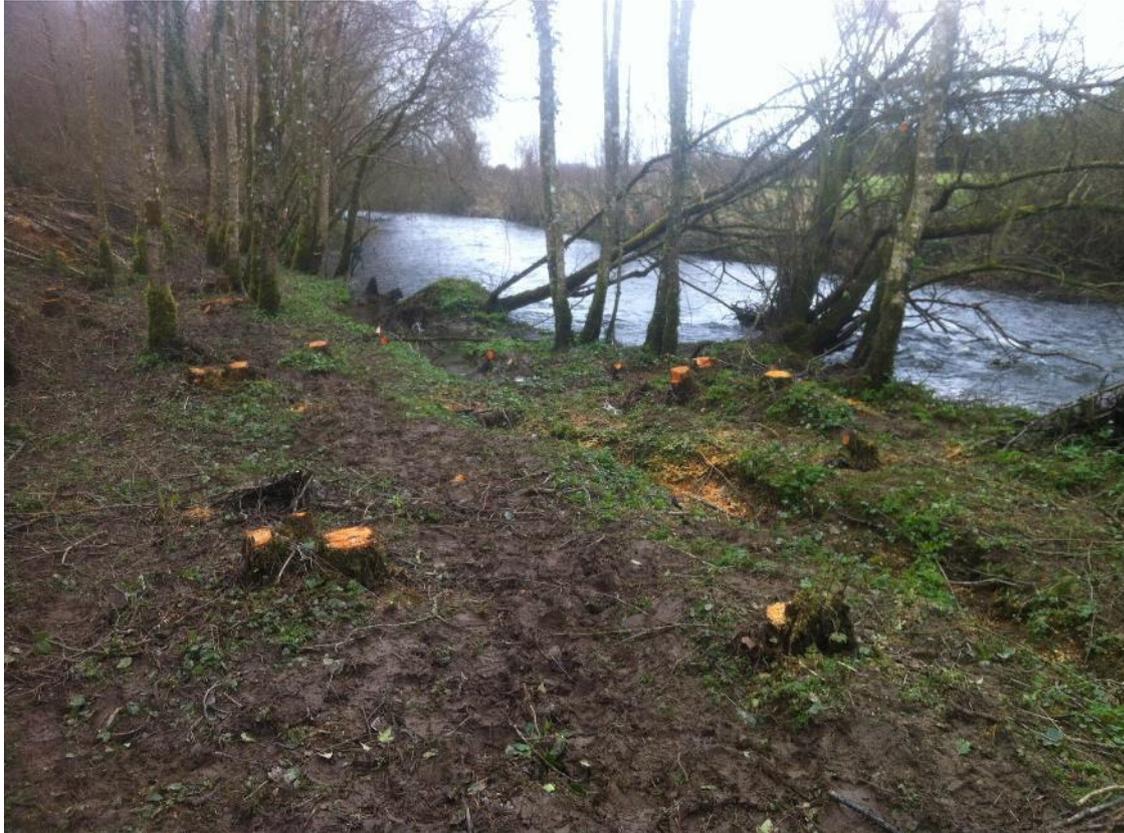
Figure 3 Bankside view of coppiced and removed trees along the Brogeen

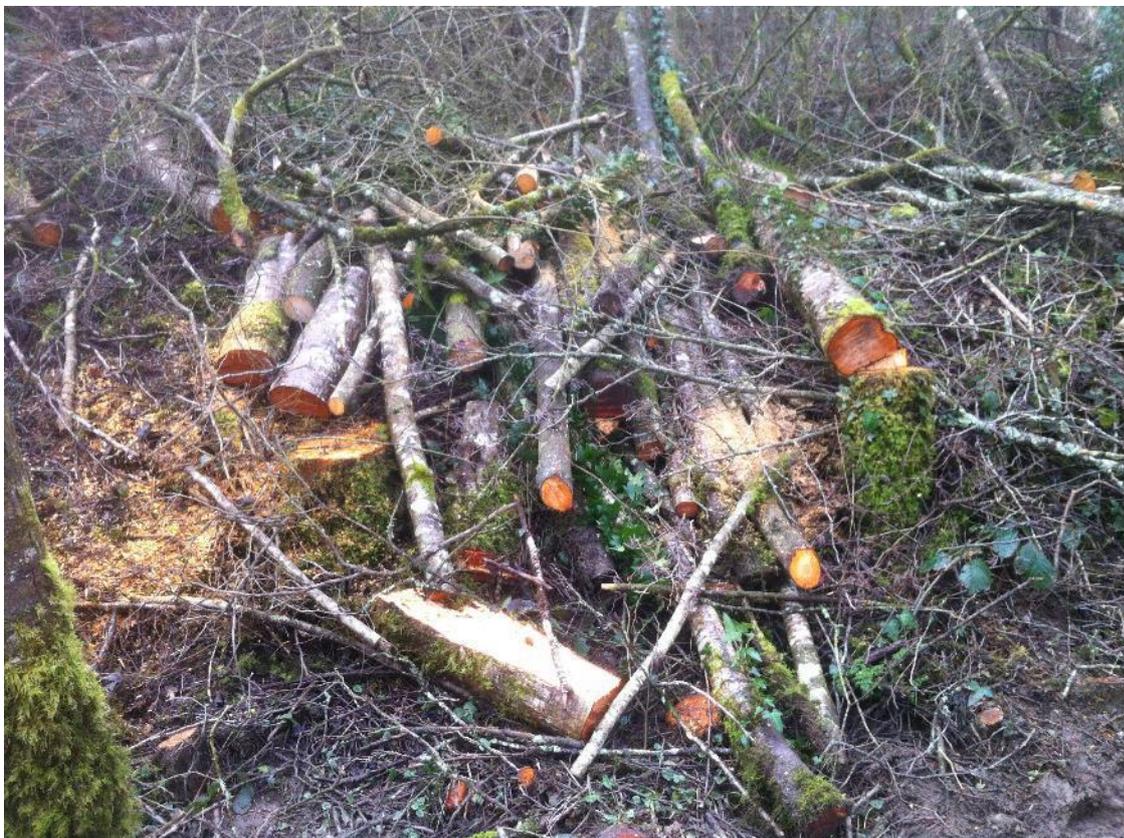
Figure 4 Trees cut down in the process of Action C5 were stockpiled and used to construct log piles for Action C7

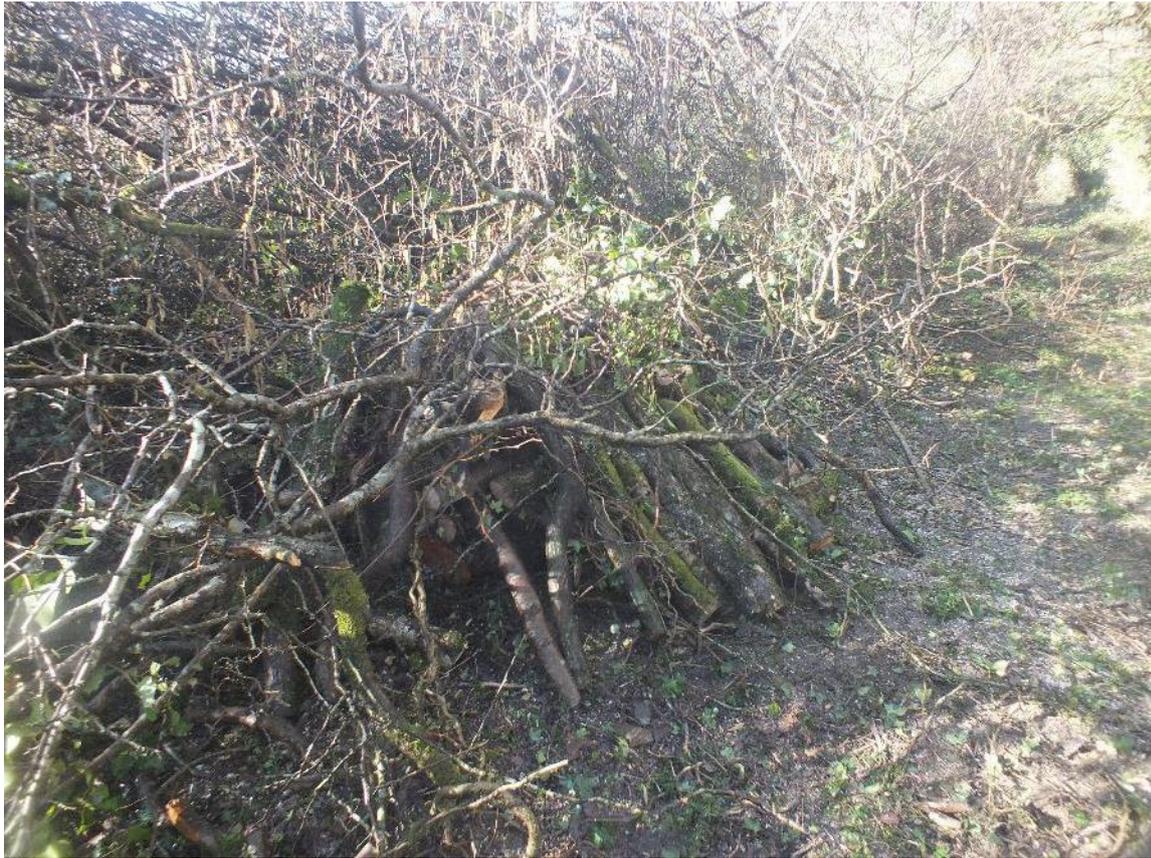
Figure 5 Otter log pile (Action C7) built with timber cut-offs from Action C5

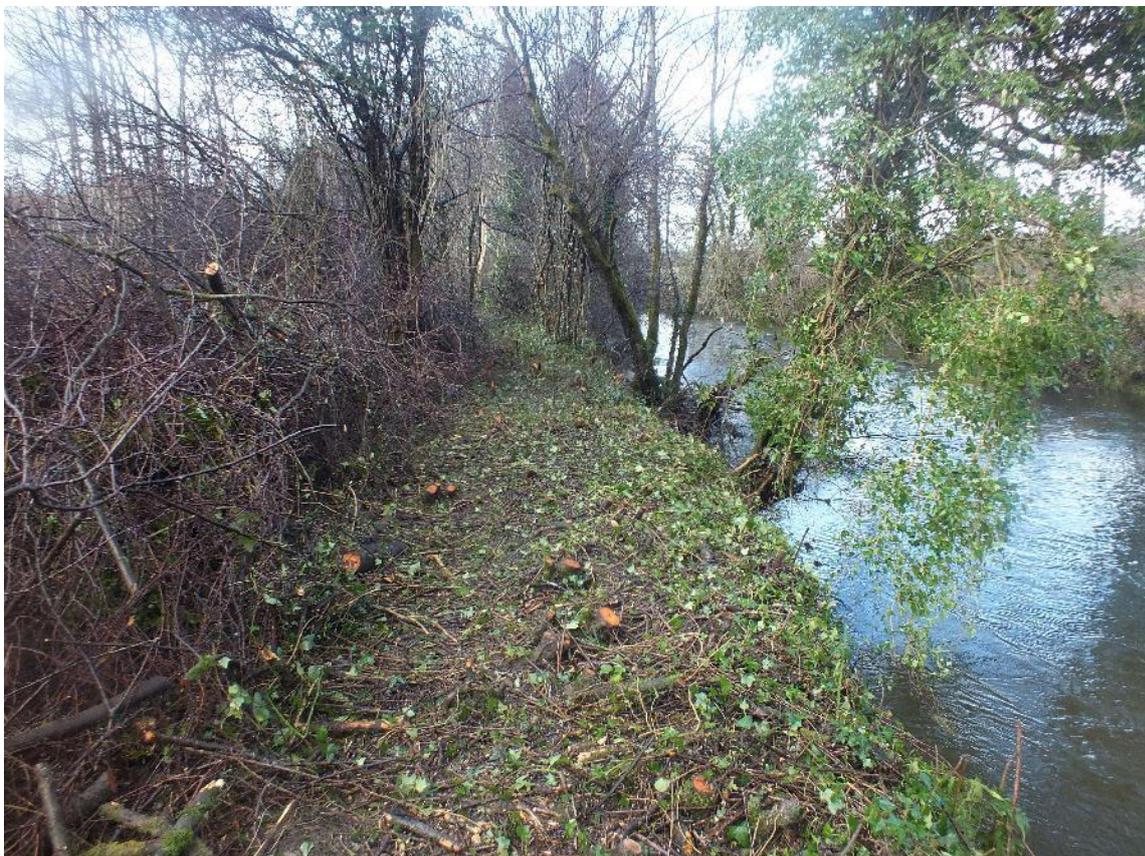
Figure 6 Bankside view of removed trees along the Dalua River

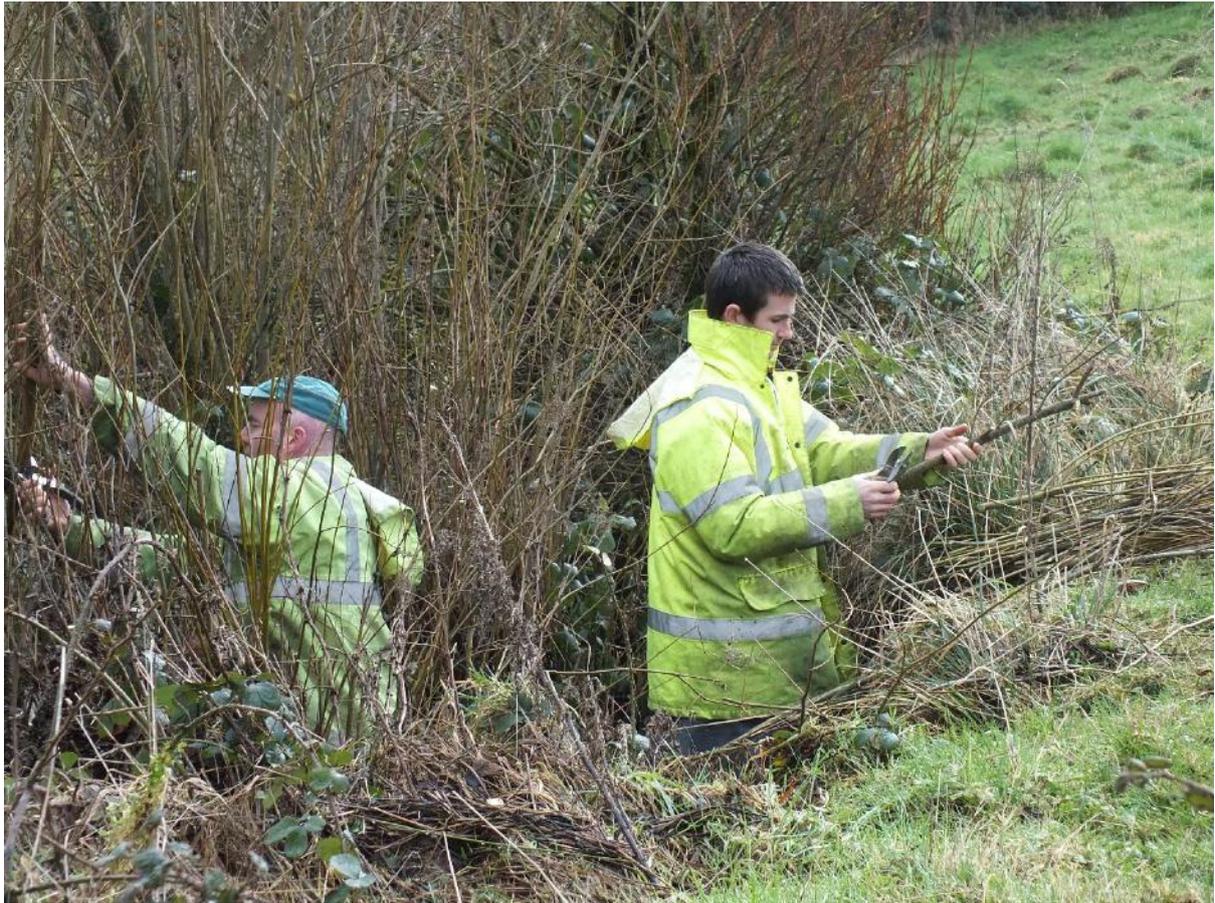
Figure 7 Pruned tree limbs were collected and used for Action C6
